Site Inspection, Kennecott Utah Copper, Bingham Canyon Mine, M/035/002, Salt

Lake County, Utah

To check whether work had begun on stripping soils and removal of sludges from the South Jordan Evaporation Ponds.

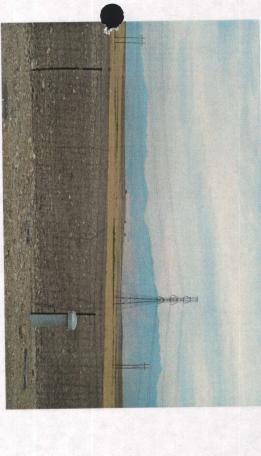
We observed the ponds from a distance (Photo 1). Although it is not readily apparent in the photograph, we were able to distinguish scrapers, a trackhoe, haul trucks, and other earth moving equipment working in the sludge removal areas. The equipment was creating enough dust that it could be seen from several miles away.

Photo 1. Equipment operating on the South Jordan Evaporation Ponds.

The Division received Kennecott Land's latest proposal for the sludge removal on August 26, 2003 and has not approved the activities presently taking place. The issuance of a notice of noncompliance for initiating this project without Division approval should be considered. There are numerous concerns about how the project is being conducted without an approved plan.

I am not certain what methods are being used to control dust or whether the operation is in compliance with Air Quality regulations. The Division should contact Air Quality and ask about the dust control concern.

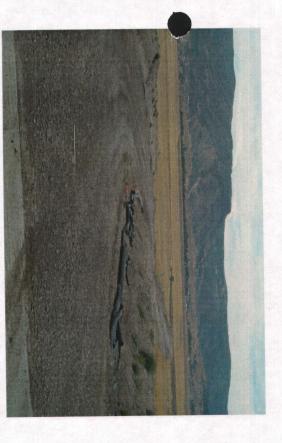
A haul road has also been constructed from the sludge storage area to Copper Notch repository. The haul road crosses public highways in two locations (Photos 2 and 4). Photo 4 shows a loaded truck hauling material toward the Copper Notch area crossing the highway.

Photo 2. The haul road leading toward Copper Notch.

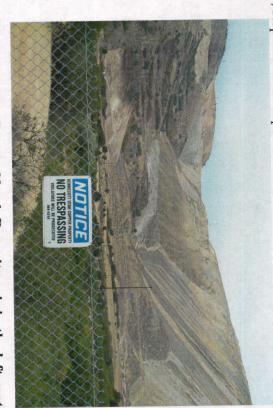
An area, within the area designated as the Copper Notch Repository, has been stripped of soil (Photo 3). It was not possible for us to see from our vantage point if any material from the sludge ponds had been placed in repository.

Photo 3. The Copper Notch Repository is in the left center portion of this photograph. Notice that soil and vegetation have been stripped.

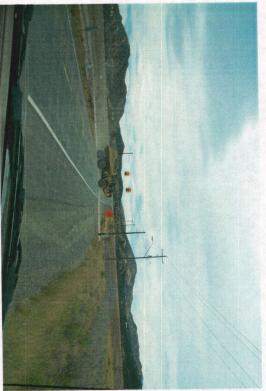
Photo 4. One of the haul road crossings over a public highway. The loaded truck is heading toward the Copper Notch area.
